**Flood Control Project Maintenance
Levee Inspections**
LMA District Cover Sheet
Spring 2016 Levee Inspection Results

Reclamation District No. 2064 River Junction

Spring 2016 Levee Inspection Results

Levee Inspection Report By Mile - Spring 2016

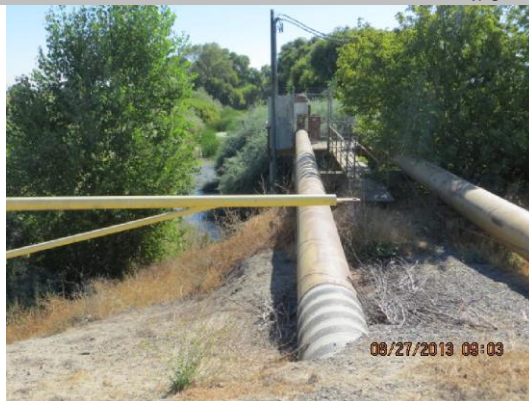
Photo 1 of 2 : UCIP_SP_2016_18718_31286.jpg

FS_ID:18718
DS_ID:20512
EP_NO: 13907
Repair Type: Non-Urgent
Crossing Status: Found
UCIP Comments: This pipe has less than 1-foot of cover.
FIELD_STRUCT_DESC: 1 of 3: 24-inch stormdrain discharge pipe through the levee 2.0 feet below the crown (Permit No. 13907, 1985). Two 100-horsepower and one 75-horsepower pumps on landward toe of levee. Siphon breaker on WS shoulder.
FS Date: 8/27/2013

Steel storm drain pipe with pump on pier in background.

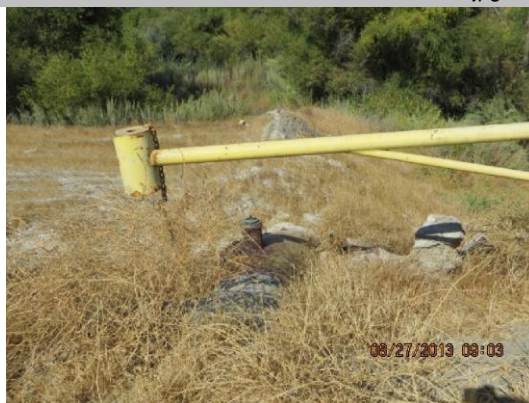
Photo 2 of 2 : UCIP_SP_2016_18718_31285.jpg

Pipe and siphon breaker visible on WS shoulder.

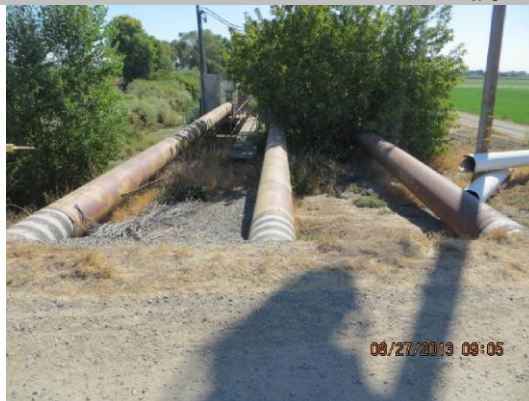
Photo 1 of 2 : UCIP_SP_2016_22729_38458.jpg

FS_ID:22729
DS_ID:20527
EP_NO: 13907
Repair Type: Non-Urgent
Crossing Status: Found
UCIP Comments: This pipe has less than 1-foot of cover.
FIELD_STRUCT_DESC: 2 of 3: 24-inch steel stormdrain discharge pipe through the levee 2.0 feet below the crown (Permit No. 13907, 1985). Two 100-horsepower and one 75-horsepower pumps on pier at landward toe of levee. Siphon breaker on WS shoulder.
FS Date: 8/27/2013

Pipe visible on LS.

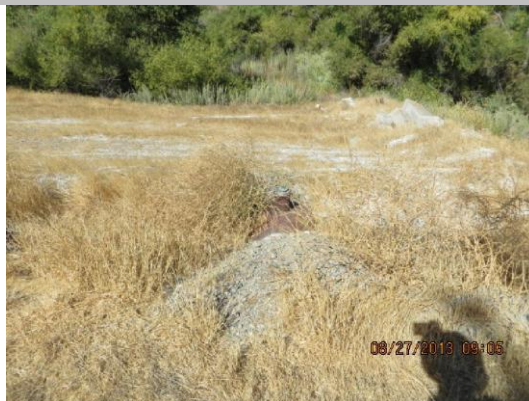
Photo 2 of 2 : UCIP_SP_2016_22729_38457.jpg

Pipe and siphon breaker on WS shoulder.

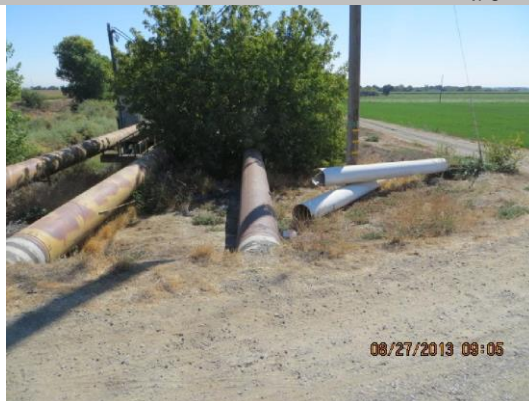
Photo 1 of 2 : UCIP_SP_2016_18720_31294.jpg

FS_ID:18720
DS_ID:20528
EP_NO: 13907
Repair Type: Non-Urgent
Crossing Status: Found
UCIP Comments: This pipe has less than 1-foot of cover.
FIELD_STRUCT_DESC: 3 of 3: 24-inch steel stormdrain discharge pipe through the levee 1.0-foot below the crown (Permit No. 13907, 1985). Two 100-horsepower and one 75-horsepower pumps on landward toe of levee. Siphon breaker on WS shoulder.
FS Date: 8/27/2013

Steel pipe visible on LS.

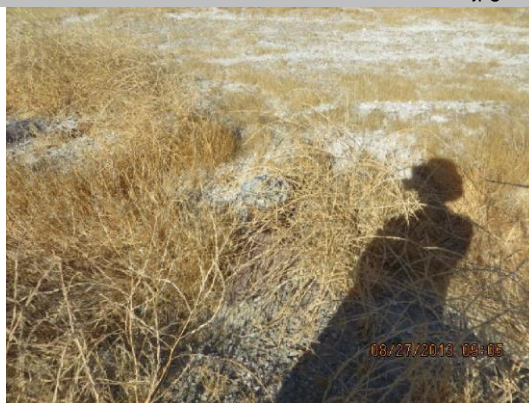
Photo 2 of 2 : UCIP_SP_2016_18720_31293.jpg

Siphon breaker visible on WS shoulder.

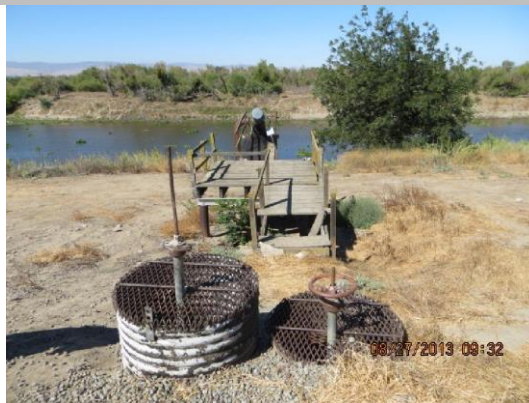
Photo 1 of 2 : UCIP_SP_2016_40792_31377.jpg

LM Start	1.23	Rating **	M	Issue No.	42
LM End	1.23	Issue Type +	En	Location *	WS
Category	Supplemental			GPS Latitude/Longitude	
				Start	End
Item	DWR UCIP Field Study			37.695529 °	37.695529 °
				-121.270005 °	-121.270005 °
DWR ID					
Comment Code					
Inspector Comment					
FS_ID:40792 DS_ID:20533 EP_NO: N/A Repair Type: Non-Urgent Crossing Status: Found UCIP Comments: Pump and slant pipe missing from structure on WS slope. FIELD_STRUCT_DESC: 12-inch steel concrete encased irrigation pipe through the levee 13.0 feet below the crown, slant pump on the WS toe. Slide gate in 36-inch CMP riser on the WS shoulder. 6'X6' concrete distribution box and filter plant on LS toe. 2-inch galvanized iron electrical conduit at same location. Originally included in the 1968 O&M manual. FS Date: 8/27/2013

Slide gate in CMP riser on WS shoulder.

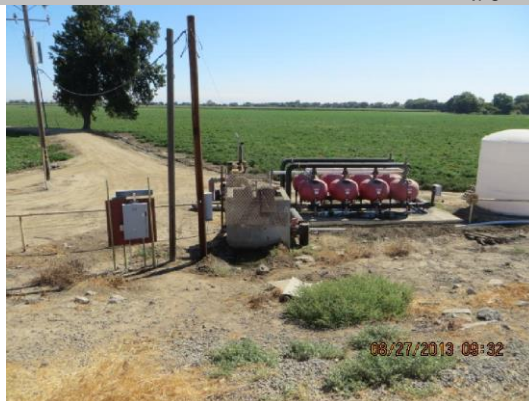
Photo 2 of 2 : UCIP_SP_2016_40792_31376.jpg

LM Start	1.23	Rating **	M	Issue No.	42 (cont)	
LM End	1.23	Issue Type +	En	Location *	WS	
Category	Supplemental			GPS Latitude/Longitude		
				Start		End
Item	DWR UCIP Field Study			37.695529 °		37.695529 °
				-121.270005 °		-121.270005 °
DWR ID						
Comment Code						
Inspector Comment						
FS_ID:40792 DS_ID:20533 EP_NO: N/A Repair Type: Non-Urgent Crossing Status: Found UCIP Comments: Pump and slant pipe missing from structure on WS slope. FIELD_STRUCT_DESC: 12-inch steel concrete encased irrigation pipe through the levee 13.0 feet below the crown, slant pump on the WS toe. Slide gate in 36-inch CMP riser on the WS shoulder. 6'X6' concrete distribution box and filter plant on LS toe. 2-inch galvanized iron electrical conduit at same location. Originally included in the 1968 O&M manual. FS Date: 8/27/2013

Concrete distribution box and filter plant on LS toe.

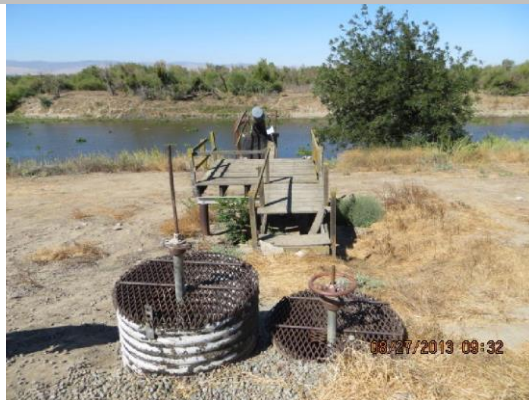
Photo 1 of 2 : UCIP_SP_2016_42940_38462.jpg

LM Start	1.23	Rating **	U	Issue No.	41
LM End	1.23	Issue Type +	En	Location *	WS
Category	Supplemental			GPS Latitude/Longitude	
				Start	End
Item	DWR UCIP Field Study			37.695506 °	37.695506 °
				-121.269995 °	-121.269995 °
DWR ID					
Comment Code					
Inspector Comment					
FS_ID:42940 DS_ID:20524 EP_NO: 3739 Repair Type: Urgent Crossing Status: Found UCIP Comments: Some leakage at connection between pipe and distro box on LS toe. This may indicate internal failure of pipe. FIELD_STRUCT_DESC: 16-inch steel irrigation pipe through the levee 10.75-feet below the crown. Slant pump on WS toe. Slide gate in 36-inch CMP riser on WS shoulder. 6'X6' concrete distribution box and filter plant on LS toe. 2-inch galvanized iron electrical conduit at same location. FS Date: 8/27/2013

Slant pump on WS toe. Slide gate in 36-inch CMP riser on WS shoulder.

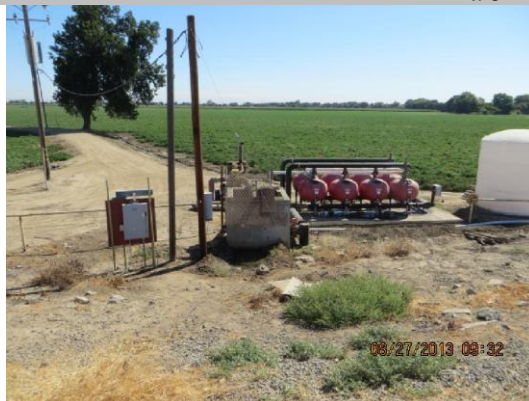
Photo 2 of 2 : UCIP_SP_2016_42940_38461.jpg

LM Start	1.23	Rating **	U	Issue No.	41 (cont)	
LM End	1.23	Issue Type +	En	Location *	WS	
Category	Supplemental			GPS Latitude/Longitude		
				Start		End
Item	DWR UCIP Field Study			37.695506 °		37.695506 °
				-121.269995 °		-121.269995 °
DWR ID						
Comment Code						
Inspector Comment						
FS_ID:42940 DS_ID:20524 EP_NO: 3739 Repair Type: Urgent Crossing Status: Found UCIP Comments: Some leakage at connection between pipe and distro box on LS toe. This may indicate internal failure of pipe. FIELD_STRUCT_DESC: 16-inch steel irrigation pipe through the levee 10.75-feet below the crown. Slant pump on WS toe. Slide gate in 36-inch CMP riser on WS shoulder. 6'X6' concrete distribution box and filter plant on LS toe. 2-inch galvanized iron electrical conduit at same location. FS Date: 8/27/2013

Concrete distribution box on LS toe with filter plant.

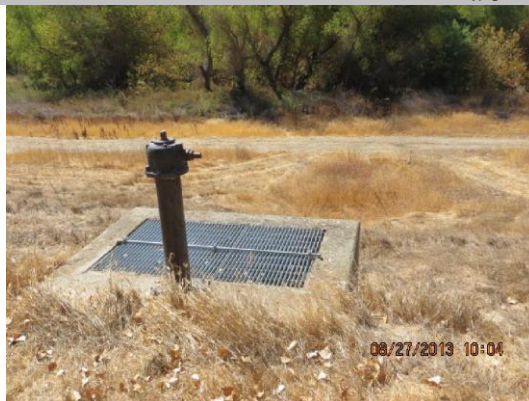
Photo 1 of 2 : UCIP_SP_2016_18763_31402.jpg

LM Start	1.94	Rating **	M	Issue No.	28
LM End	1.94	Issue Type +	En	Location *	WS
Category	Supplemental			GPS Latitude/Longitude	
				Start	End
Item	DWR UCIP Field Study			37.689900 °	37.689900 °
				-121.264802 °	-121.264802 °
DWR ID					
Comment Code					
Inspector Comment					
FS_ID:18763					
DS_ID:20515					
EP_NO: N/A					
Repair Type: Non-Urgent					
Crossing Status: Found					
UCIP Comments: Culvert filled nearly to the top with soil.					
FIELD_STRUCT_DESC: 30-inch square reinforced concrete stormdrain					
box culvert through the levee 14.7-feet below the crown. Slide gate in					
concrete riser unit on the waterward slope. Concrete "U" shaped					
headwalls on both ends. Flap gate on the waterward end. Originally					
included in the 1968 O&M manual.					
FS Date: 8/27/2013

Slide gate in Concrete riser on WS shoulder.

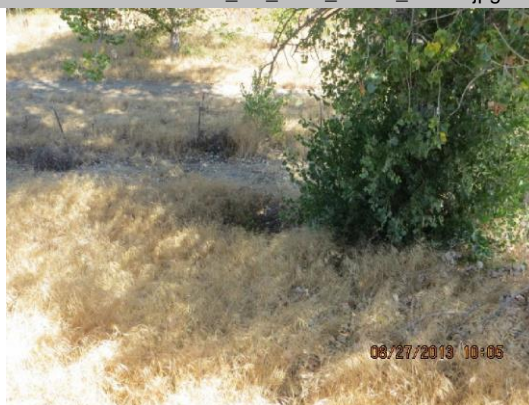
Photo 2 of 2 : UCIP_SP_2016_18763_31401.jpg

Concrete U-shaped headwall on LS toe.

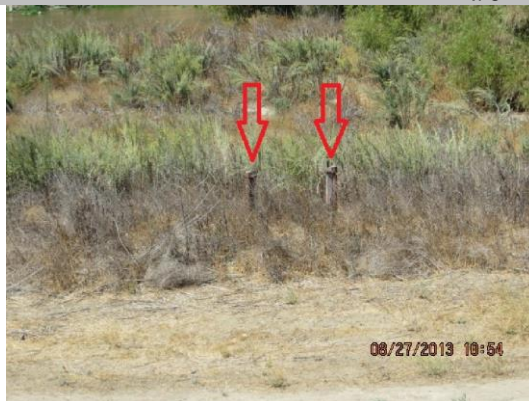
Photo 1 of 1 : UCIP_SP_2016_22731_38463.jpg

LM Start	3.46	Rating **	M	Issue No.	37
LM End	3.46	Issue Type +	En	Location *	WS
Category	Supplemental			GPS Latitude/Longitude	
				Start	End
Item	DWR UCIP Field Study			37.676751 °	37.676751 °
				-121.264193 °	-121.264193 °
DWR ID					
Comment Code					
Inspector Comment					
FS_ID:22731 DS_ID:20517 EP_NO: N/A Repair Type: Non-Urgent Crossing Status: Indicator Found UCIP Comments: Neet to verify status of pipeline. FIELD_STRUCT_DESC: Underground gas line crossing; depth through the levee and size unknown. Found possible sign posts on WS toe. FS Date: 8/27/2013

Possible sign posts on WS toe.

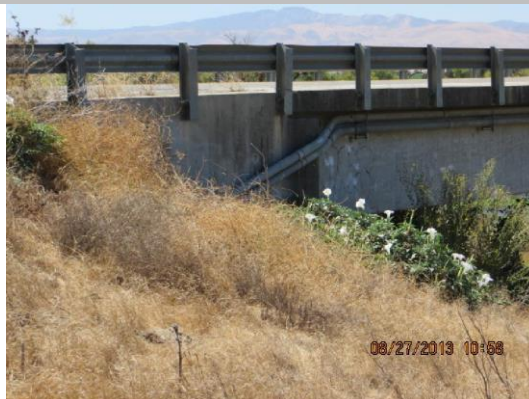
Photo 1 of 1 : UCIP_SP_2016_22085_37702.jpg

LM Start	3.49	Rating **	M	Issue No.	31
LM End	3.49	Issue Type +	En	Location *	WS
Category	Supplemental			GPS Latitude/Longitude	
				Start	End
Item	DWR UCIP Field Study			37.676276 °	37.676276 °
				-121.264104 °	-121.264104 °
DWR ID					
Comment Code					
Inspector Comment					
FS_ID:22085 DS_ID:24059 EP_NO: N/A Repair Type: Non-Urgent Crossing Status: Found UCIP Comments: Unable to identify purpose or permit for this crossing. FIELD_STRUCT_DESC: 1 of 2: 4-inch galvanized iron conduit through the levee at unknown depth below the crown. Visible on downstream side of the bridge. 3.5-foot by 6-foot steel vault on crown. FS Date: 8/27/2013

Upper conduit visible on DS side of bridge.

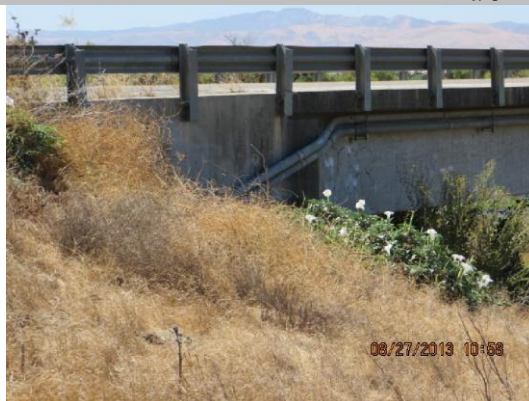
Photo 1 of 1 : UCIP_SP_2016_22790_38826.jpg

LM Start	3.49	Rating **	M	Issue No.	40
LM End	3.49	Issue Type +	En	Location *	WS
Category	Supplemental			GPS Latitude/Longitude	
				Start	End
Item	DWR UCIP Field Study			37.676276 °	37.676276 °
				-121.264104 °	-121.264104 °
DWR ID					
Comment Code					
Inspector Comment					
FS_ID:22790 DS_ID:24060 EP_NO: N/A Repair Type: Non-Urgent Crossing Status: Found UCIP Comments: Unable to identify purpose or permit for this crossing. FIELD_STRUCT_DESC: 2 of 2: 4-inch galvanized iron conduit through the levee at unknown depth below the crown. Visible on downstream side of the bridge. 3.5-foot by 6-foot steel vault on crown. FS Date: 8/27/2013

Lower conduit visible on DS side of bridge at WS slope.

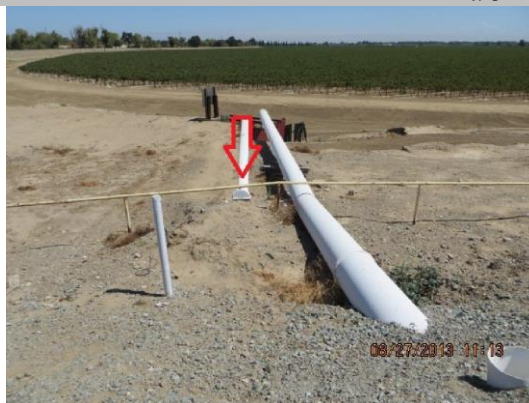
Photo 1 of 2 : UCIP_SP_2016_19044_31844.jpg

LM Start	3.57	Rating **	M	Issue No.	32
LM End	3.57	Issue Type +	En	Location *	WS
Category	Supplemental			GPS Latitude/Longitude	
				Start	End
Item	DWR UCIP Field Study			37.675267 °	37.675267 °
				-121.263426 °	-121.263426 °
DWR ID					
Comment Code					
Inspector Comment					
FS_ID:19044 DS_ID:20519 EP_NO: 6450 Repair Type: Non-Urgent Crossing Status: Found UCIP Comments: Appears abandoned and if so should be done so properly. FIELD_STRUCT_DESC: 18-inch steel discharge pipe through the levee 2-feet below the crown. Crown roadway padded over the pipe. Pipe exposed on both slopes. Gate valve on the LS toe. Pump missing from sump with sheet pile siding in ditch on the landside. Siphon breaker on the waterward side (Permit No. 6450, 1969). FS Date: 8/27/2013

Pipe and gate valve on LS toe.

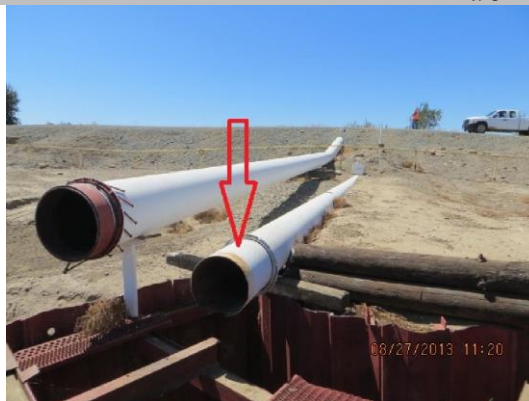
Photo 2 of 2 : UCIP_SP_2016_19044_31843.jpg

LM Start	3.57	Rating **	M	Issue No.	32 (cont)	
LM End	3.57	Issue Type +	En	Location *	WS	
Category	Supplemental			GPS Latitude/Longitude		
				Start		End
Item	DWR UCIP Field Study			37.675267 °		37.675267 °
				-121.263426 °		-121.263426 °
DWR ID						
Comment Code						
Inspector Comment						
FS_ID:19044 DS_ID:20519 EP_NO: 6450 Repair Type: Non-Urgent Crossing Status: Found UCIP Comments: Appears abandoned and if so should be done so properly. FIELD_STRUCT_DESC: 18-inch steel discharge pipe through the levee 2-feet below the crown. Crown roadway padded over the pipe. Pipe exposed on both slopes. Gate valve on the LS toe. Pump missing from sump with sheet pile siding in ditch on the landside. Siphon breaker on the waterward side (Permit No. 6450, 1969). FS Date: 8/27/2013

Pipe visible at sump off LS toe. No pump or appurtenances.

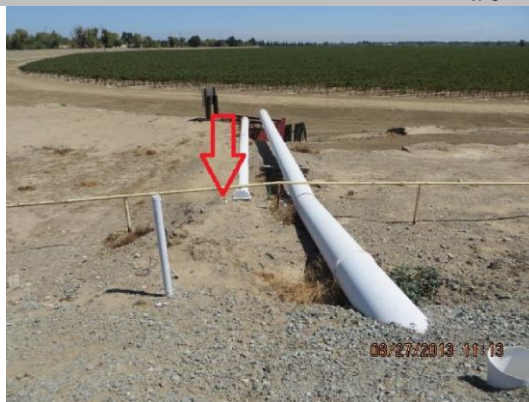
Photo 1 of 2 : UCIP_SP_2016_22732_38465.jpg

LM Start	3.57	Rating **	M	Issue No.	38
LM End	3.57	Issue Type +	En	Location *	WS
Category	Supplemental			GPS Latitude/Longitude	
				Start	End
Item	DWR UCIP Field Study			37.675266 °	37.675266 °
				-121.263421 °	-121.263421 °
DWR ID					
Comment Code					
Inspector Comment					
FS_ID:22732 DS_ID:20525 EP_NO: N/A Repair Type: Non-Urgent Crossing Status: Found UCIP Comments: Need to determine if pipe was actually removed from levee. FIELD_STRUCT_DESC: 12-inch steel stormdrain pipe through the levee at unknown depth below the crown. Steel plate welded over LS end at LS toe. Permit No. 6450, states it was removed in 1973, but it remains visible on the LS toe. Originally included in the 1968 O&M manual. FS Date: 8/27/2013

Pipe visible on LS toe.

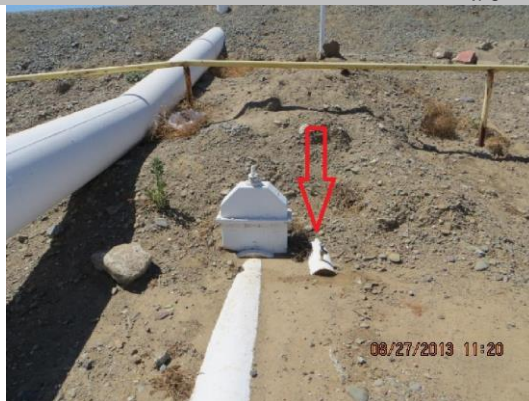
Photo 2 of 2 : UCIP_SP_2016_22732_38464.jpg

LM Start	3.57	Rating **	M	Issue No.	38 (cont)	
LM End	3.57	Issue Type +	En	Location *	WS	
Category	Supplemental			GPS Latitude/Longitude		
				Start		End
Item	DWR UCIP Field Study			37.675266 °	37.675266 °	
				-121.263421 °	-121.263421 °	
DWR ID						
Comment Code						
Inspector Comment						
FS_ID:22732						
DS_ID:20525						
EP_NO: N/A						
Repair Type: Non-Urgent						
Crossing Status: Found						
UCIP Comments: Need to determine if pipe was actually removed from levee.						
FIELD_STRUCT_DESC: 12-inch steel stormdrain pipe through the levee at unknown depth below the crown. Steel plate welded over LS end at LS toe. Permit No. 6450, states it was removed in 1973, but it remains visible on the LS toe. Originally included in the 1968 O&M manual.						
FS Date: 8/27/2013

Pipe with welded steel plate over LS end at LS toe.

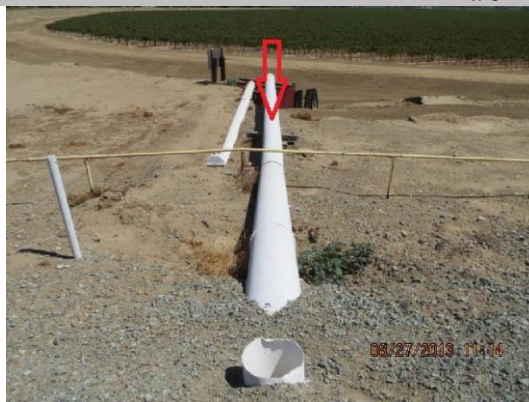
Photo 1 of 2 : UCIP_SP_2016_22733_38468.jpg

LM Start	3.57	Rating **	M	Issue No.	39
LM End	3.57	Issue Type +	En	Location *	WS
Category	Supplemental			GPS Latitude/Longitude	
				Start	End
Item	DWR UCIP Field Study			37.675247 °	37.675247 °
				-121.263398 °	-121.263398 °
DWR ID					
Comment Code					
Inspector Comment					
FS_ID:22733					
DS_ID:20522					
EP_NO: 13609					
Repair Type: Non-Urgent					
Crossing Status: Found					
UCIP Comments: Appears abandoned and should be done so properly. Pipe was to be removed in 1984.					
FIELD_STRUCT_DESC: 1 of 2: 24-inch steel discharge pipe through the levee 2-feet below the crown (Permit No. 13609, 1983). Approx. 420 feet upstream of Durham Ferry-Airport Way Road.					
FS Date: 8/27/2013

Pipe and vent visible on LS slope.

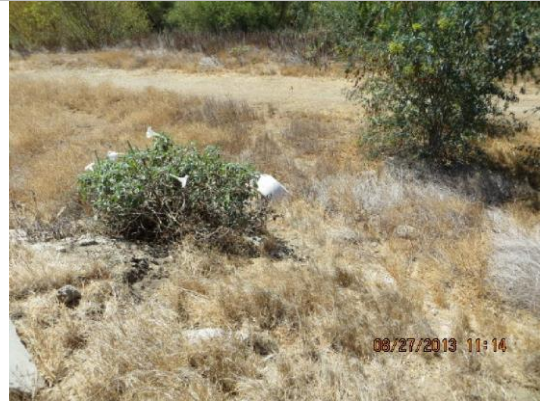
Photo 2 of 2 : UCIP_SP_2016_22733_38467.jpg

LM Start	3.57	Rating **	M	Issue No.	39 (cont)	
LM End	3.57	Issue Type +	En	Location *	WS	
Category	Supplemental			GPS Latitude/Longitude		
				Start	End	
Item	DWR UCIP Field Study			37.675247 °	37.675247 °	
				-121.263398 °	-121.263398 °	
DWR ID						
Comment Code						
Inspector Comment						
FS_ID:22733 DS_ID:20522 EP_NO: 13609 Repair Type: Non-Urgent Crossing Status: Found UCIP Comments: Appears abandoned and should be done so properly. Pipe was to be removed in 1984. FIELD_STRUCT_DESC: 1 of 2: 24-inch steel discharge pipe through the levee 2-feet below the crown (Permit No. 13609, 1983). Approx. 420 feet upstream of Durham Ferry-Airport Way Road. FS Date: 8/27/2013

Pipe visible on WS slope.

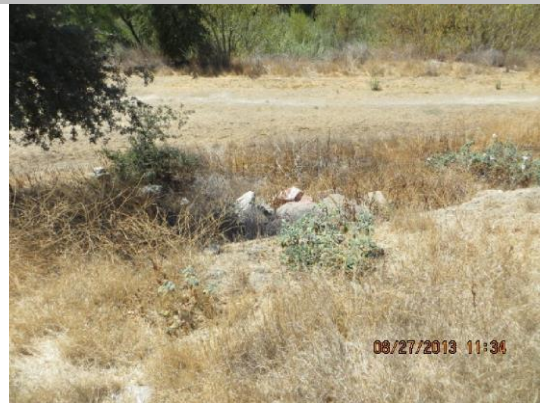
Photo 1 of 2 : UCIP_SP_2016_19046_31849.jpg

LM Start	3.60	Rating **	M	Issue No.	33
LM End	3.60	Issue Type +	En	Location *	WS
Category	Supplemental			GPS Latitude/Longitude	
				Start	End
Item	DWR UCIP Field Study			37.675005 °	37.675005 °
				-121.263103 °	-121.263103 °
DWR ID					
Comment Code					
Inspector Comment					
FS_ID:19046 DS_ID:20534 EP_NO: 13609 Repair Type: Non-Urgent Crossing Status: Indicator Found UCIP Comments: Pipes should be abandoned properly. FIELD_STRUCT_DESC: 2 of 2: *Removed* 24-inch steel pipe through levee 12.67 feet below crown (Permit No. 13609, 1983). Approx. 75 feet upstream of first 24-inch pipe. According to notes in permit, Concrete rubble was placed over pipe on WS slope. FS Date: 8/27/2013

Concrete rubble on WS slope possible indicator of abandoned pipe location.

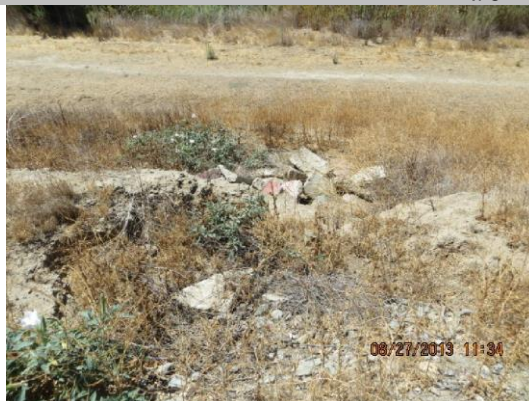
Photo 2 of 2 : UCIP_SP_2016_19046_31848.jpg

LM Start	3.60	Rating **	M	Issue No.	33 (cont)
LM End	3.60	Issue Type +	En	Location *	WS
Category	Supplemental			GPS Latitude/Longitude	
				Start	End
Item	DWR UCIP Field Study			37.675005 °	37.675005 °
				-121.263103 °	-121.263103 °
DWR ID					
Comment Code					
Inspector Comment					
FS_ID:19046 DS_ID:20534 EP_NO: 13609 Repair Type: Non-Urgent Crossing Status: Indicator Found UCIP Comments: Pipes should be abandoned properly. FIELD_STRUCT_DESC: 2 of 2: *Removed* 24-inch steel pipe through levee 12.67 feet below crown (Permit No. 13609, 1983). Approx. 75 feet upstream of first 24-inch pipe. According to notes in permit, Concrete rubble was placed over pipe on WS slope. FS Date: 8/27/2013

Concrete rubble on WS slope possible indicator of abandoned pipe location.

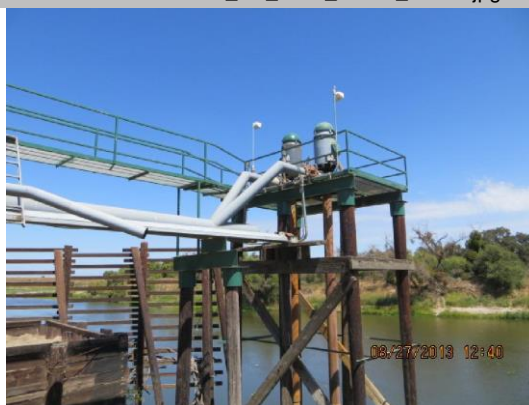
Photo 2 of 2 : UCIP_SP_2016_19063_31860.jpg

LM Start	4.72	Rating **	M	Issue No.	34
LM End	4.72	Issue Type +	En	Location *	LS
Category	Supplemental			GPS Latitude/Longitude	
				Start	End
Item	DWR UCIP Field Study			37.670161 °	37.670161 °
				-121.246973 °	-121.246973 °
DWR ID					
Comment Code					
Inspector Comment					
FS_ID:19063 DS_ID:20520 EP_NO: 3359 Repair Type: Non-Urgent Crossing Status: Indicator Found UCIP Comments: Pipe not found. Need to determine disposition of pipe as all other appurtances remain. FIELD_STRUCT_DESC: 1 of 2: 24-inch pipe through the levee 3.5 feet below the crown (Permit No. 3359, 1961). Pump mounted on pipe structure in the river; protective fender in the stream, wooden walkway to the pump structure. Siphon breaker on the landward side. Originally included in the 1968 O&M manual. FS Date: 8/27/2013

Pump platform, walkway, and fender remain in stream. No 24-inch pipe found.

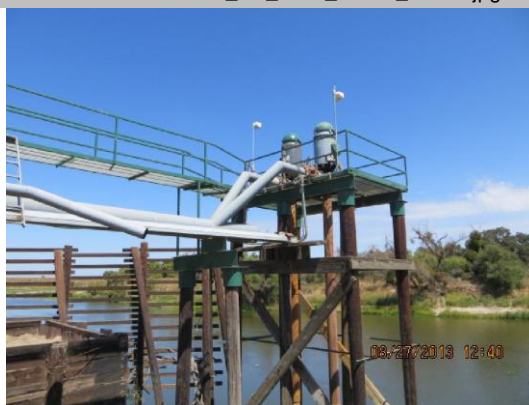
Photo 2 of 2 : UCIP_SP_2016_19064_31862.jpg

LM Start	4.72	Rating **	M	Issue No.	35
LM End	4.72	Issue Type +	En	Location *	LS
Category	Supplemental			GPS Latitude/Longitude	
				Start	End
Item	DWR UCIP Field Study			37.670161 °	37.670161 °
				-121.246973 °	-121.246973 °
DWR ID					
Comment Code					
Inspector Comment					
FS_ID:19064 DS_ID:20530 EP_NO: 3359 Repair Type: Non-Urgent Crossing Status: Indicator Found UCIP Comments: Pipe not found. Need to determine disposition of pipe as all other appurtances remain. FIELD_STRUCT_DESC: 2 of 2: 18-inch pipe through levee 3.5 feet below the crown (Permit No. 3359, 1961). Pump mounted on pipe structure in the river; protective fender in the stream, wooden walkway to the pump structure. Siphon breaker on the landward side. Originally included in the 1968 O&M manual. FS Date: 8/27/2013

Pump platform and fender visible on WS toe.

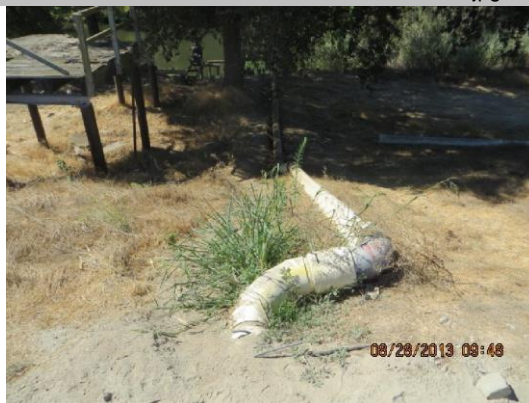
Photo 2 of 2 : UCIP_SP_2016_44653_37714.jpg

LM Start	0.33	Rating **	M	Issue No.	28
LM End	0.33	Issue Type +	En	Location *	WS
Category	Supplemental			GPS Latitude/Longitude	
				Start	End
Item	DWR UCIP Field Study			37.664752 °	37.664752 °
				-121.236512 °	-121.236512 °
DWR ID					
Comment Code					
Inspector Comment					
FS_ID:44653					
DS_ID:24062					
EP_NO: N/A					
Repair Type: Non-Urgent					
Crossing Status: Found					
UCIP Comments: Plan of action in progress to install permanant pipe and pump by August 2015. No permit identified for large PVC irrigation pipe with inadequate cover.					
FIELD_STRUCT_DESC: 8-inch PVC irrigation pipe through the levee 0.5-feet below the crown. Portable pump on the WS berm and a filter plant on the LS toe. Vent at filter plant on LS toe.					
FS Date: 4/22/2015

Pipe visible on WS shoulder/slope.

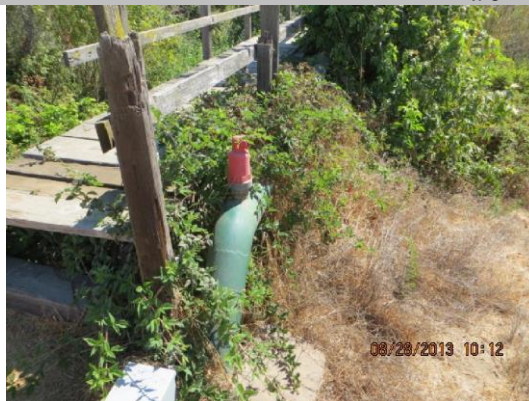
Photo 1 of 2 : UCIP_SP_2016_22095_37722.jpg

LM Start	1.97	Rating **	M	Issue No.	22
LM End	1.97	Issue Type +	En	Location *	WS
Category	Supplemental			GPS Latitude/Longitude	
				Start	End
Item	DWR UCIP Field Study			37.676454 °	37.676454 °
				-121.223204 °	-121.223204 °
DWR ID					
Comment Code					
Inspector Comment					
FS_ID:22095 DS_ID:24063 EP_NO: N/A Repair Type: Non-Urgent Crossing Status: Found UCIP Comments: No permit identified for this crossing. FIELD_STRUCT_DESC: 6-inch steel irrigation pipe through the levee at unknown depth below the crown. Pump on wooden pier at WS . Vent between 2 steel bollards on LS shoulder. Filter plant on LS toe. 1.5-inch galvanized iron electrical conduit at same location. FS Date: 8/27/2013

Pipe and vent visible on WS shoulder at wooden walkway.

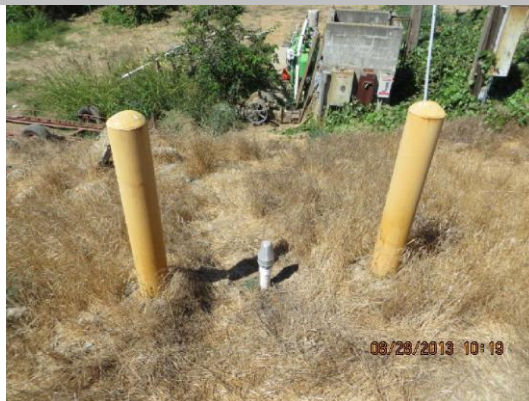
Photo 2 of 2 : UCIP_SP_2016_22095_37721.jpg

Vent on LS shoulder.

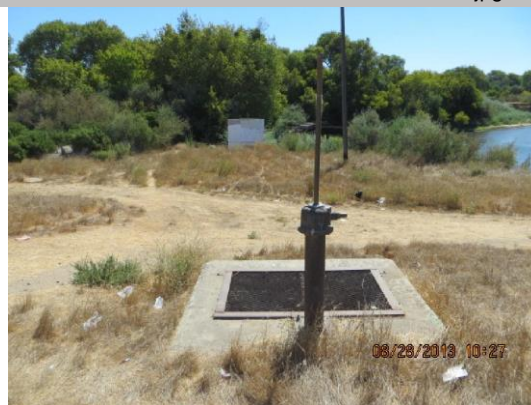
Photo 1 of 2 : UCIP_SP_2016_19086_31954.jpg

LM Start	2.53	Rating **	M	Issue No.	21
LM End	2.53	Issue Type +	En	Location *	WS
Category	Supplemental			GPS Latitude/Longitude	
				Start	End
Item	DWR UCIP Field Study			37.684148 °	37.684148 °
				-121.223599 °	-121.223599 °
DWR ID					
Comment Code					
Inspector Comment					
FS_ID:19086 DS_ID:20540 EP_NO: N/A Repair Type: Non-Urgent Crossing Status: Found UCIP Comments: Leak next to roadway may indicate pipe has reached life capacity-good candidate for video inspection. FIELD_STRUCT_DESC: 30-inch reinforced concrete box culvert through the levee 14.5-feet below the crown. Pipe reduced to 24-inch through the berm to pump house. Slide gate in 6'X7' concrete riser unit on the waterward slope. Slant pump mounted on WS berm next to 5'X9' concrete riser. 1.5-inch electrical conduit at same location. Originally included in the 1968 O&M manual. FS Date: 8/28/2013

Gate valve on WS shoulder. Pump next to concrete riser in background.

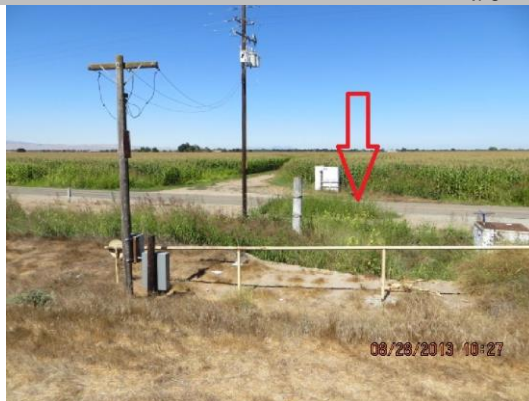
Photo 2 of 2 : UCIP_SP_2016_19086_31953.jpg

LM Start	2.53	Rating **	M	Issue No.	21 (cont)	
LM End	2.53	Issue Type +	En	Location *	WS	
Category	Supplemental			GPS Latitude/Longitude		
				Start		End
Item	DWR UCIP Field Study			37.684148 °	37.684148 °	
				-121.223599 °	-121.223599 °	
DWR ID						
Comment Code						
Inspector Comment						
FS_ID:19086 DS_ID:20540 EP_NO: N/A Repair Type: Non-Urgent Crossing Status: Found UCIP Comments: Leak next to roadway may indicate pipe has reached life capacity-good candidate for video inspection. FIELD_STRUCT_DESC: 30-inch reinforced concrete box culvert through the levee 14.5-feet below the crown. Pipe reduced to 24-inch through the berm to pump house. Slide gate in 6'X7' concrete riser unit on the waterward slope. Slant pump mounted on WS berm next to 5'X9' concrete riser. 1.5-inch electrical conduit at same location. Originally included in the 1968 O&M manual. FS Date: 8/28/2013

Wet area next to roadway off LS toe may indicate a leak. Power pole and meter on LS toe.

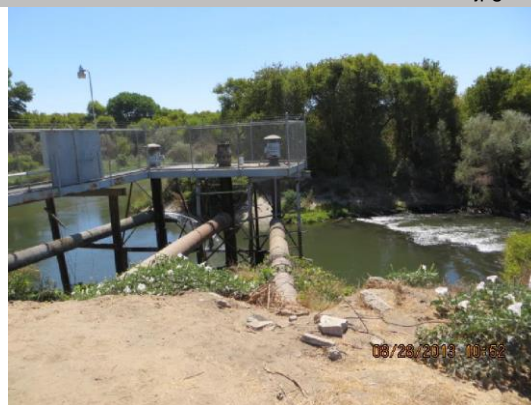
Photo 1 of 2 : UCIP_SP_2016_41075_31963.jpg

LM Start	4.19	Rating **	M	Issue No.	27
LM End	4.19	Issue Type +	En	Location *	LS
Category	Supplemental			GPS Latitude/Longitude	
				Start	End
Item	DWR UCIP Field Study			37.695198 °	37.695198 °
				-121.206414 °	-121.206414 °
DWR ID					
Comment Code					
Inspector Comment					
FS_ID:41075					
DS_ID:20542					
EP_NO: N/A					
Repair Type: Non-Urgent					
Crossing Status: Found					
UCIP Comments: Gate missing from LS ditch.					
FIELD_STRUCT_DESC: 24-inch steel irrigation pipe through the levee					
6.0-feet below the crown. Slide gate in 36-inch corrugated metal riser					
unit on the waterward side. Pump mounted on pile structure in the river.					
Pipe discharges into cobble grouted spillway on the landward side. Flap					
gate on the landward side. Originally included in the 1968 O&M manual.					
FS Date: 8/28/2013

Pipe and pump visible on WS berm.

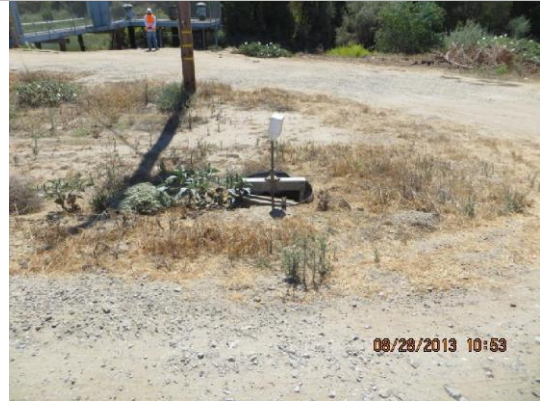
Photo 2 of 2 : UCIP_SP_2016_41075_31962.jpg

LM Start	4.19	Rating **	M	Issue No.	27 (cont)	
LM End	4.19	Issue Type +	En	Location *	LS	
Category	Supplemental			GPS Latitude/Longitude		
				Start	End	
Item	DWR UCIP Field Study			37.695198 °	37.695198 °	
				-121.206414 °	-121.206414 °	
DWR ID						
Comment Code						
Inspector Comment						
FS_ID:41075						
DS_ID:20542						
EP_NO: N/A						
Repair Type: Non-Urgent						
Crossing Status: Found						
UCIP Comments: Gate missing from LS ditch.						
FIELD_STRUCT_DESC: 24-inch steel irrigation pipe through the levee						
6.0-feet below the crown. Slide gate in 36-inch corrugated metal riser						
unit on the waterward side. Pump mounted on pile structure in the river.						
Pipe discharges into cobble grouted spillway on the landward side. Flap						
gate on the landward side. Originally included in the 1968 O&M manual.						
FS Date: 8/28/2013

Slide gate in 36-inch CMP riser on WS slope.

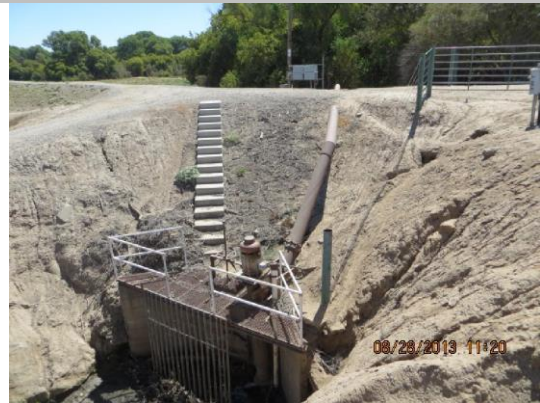
Photo 1 of 2 : UCIP_SP_2016_22107_37736.jpg

LM Start	4.24	Rating **	M	Issue No.	23
LM End	4.24	Issue Type +	En	Location *	LS
Category	Supplemental			GPS Latitude/Longitude	
				Start	End
Item	DWR UCIP Field Study			37.695745 °	37.695745 °
				-121.205865 °	-121.205865 °
DWR ID					
Comment Code					
Inspector Comment					
FS_ID:22107 DS_ID:24064 EP_NO: N/A Repair Type: Non-Urgent Crossing Status: Found UCIP Comments: Pipe does not have adequate cover at crown. FIELD_STRUCT_DESC: 12-inch steel discharge pipe through the levee 0.5-feet below the crown. Pump on concrete headwall at LS toe. Pipe discharges into 6'X7' concrete box on WS shoulder. FS Date: 8/28/2013

Pump for pipe on concrete headwall at LS toe.

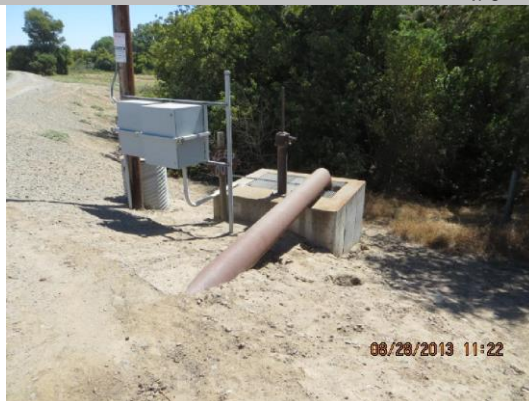
Photo 2 of 2 : UCIP_SP_2016_22107_37735.jpg

Pipe discharges into concrete riser on WS slope.

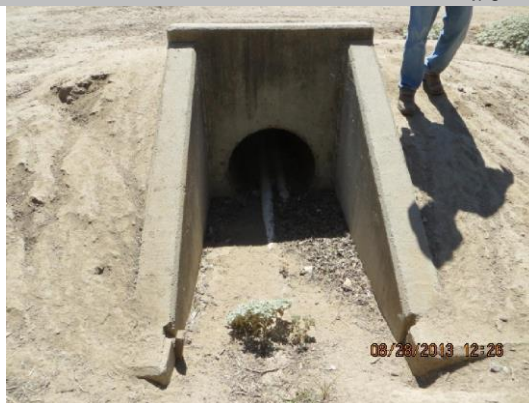
Photo 1 of 2 : UCIP_SP_2016_22108_37739.jpg

PVC pipe at right inside stormdrain on LS toe.

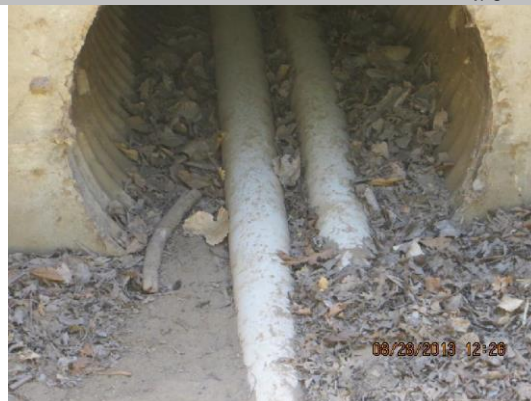
Photo 2 of 2 : UCIP_SP_2016_22108_37738.jpg

PVC pipe at right inside stormdrain on LS toe.

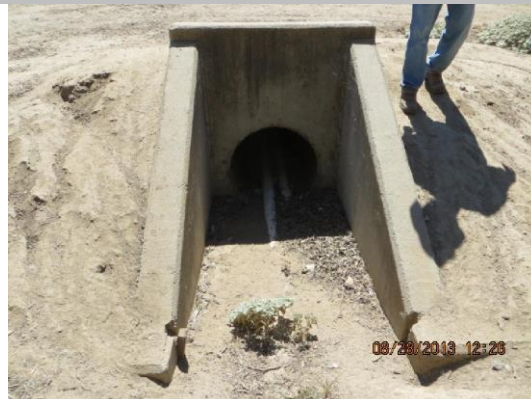
Photo 1 of 2 : UCIP_SP_2016_22109_37742.jpg

PVC conduit at left on LS toe.

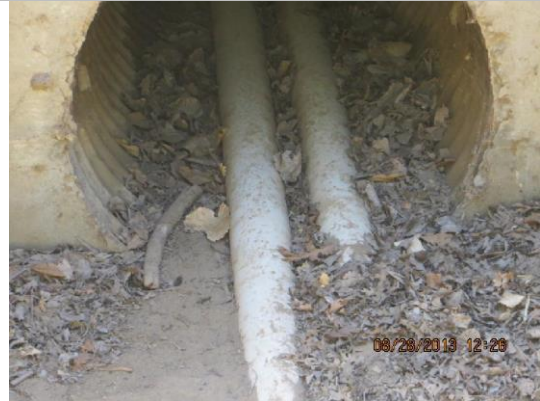
Photo 2 of 2 : UCIP_SP_2016_22109_37741.jpg

PVC conduit at left on LS toe.

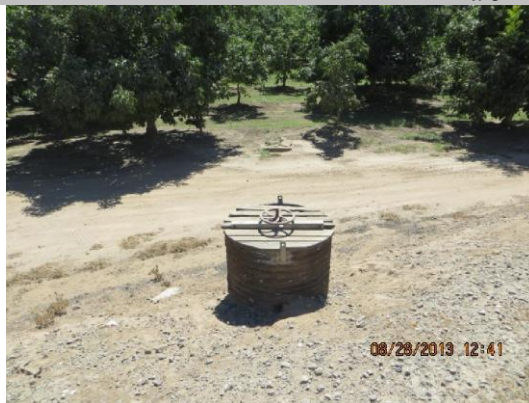
Photo 1 of 2 : UCIP_SP_2016_19145_32126.jpg

Slide gate in CMP riser on WS slope

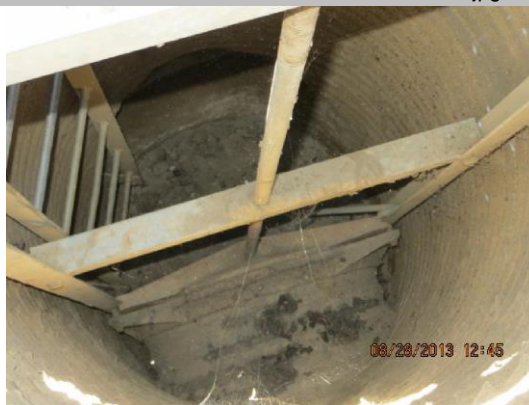
Photo 2 of 2 : UCIP_SP_2016_19145_32125.jpg

Pipe in CMP riser on WS slope.

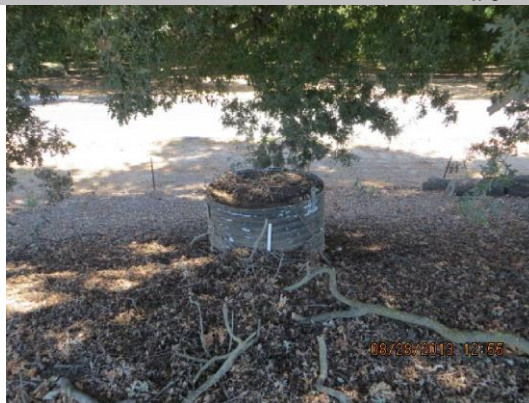
Photo 1 of 1 : UCIP_SP_2016_19146_32127.jpg

CMP riser for slide gate filled with soil.
